Ultrasonic Evaluation of Interconnecting Pipe Adhesive Joints in Glass Fiber Reinforced Polymer Pipelines

Abstract

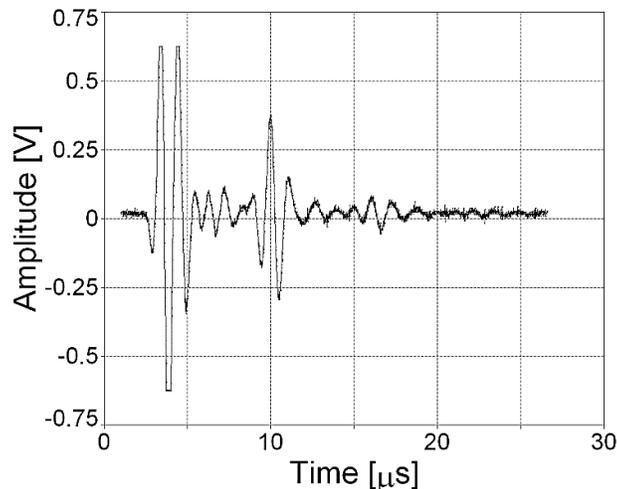
On fig. 3 is presented typical A-Scan of the zone where the pipe is bonded with the coupling. The first echo observed at time about 4 μs is from the top surface of the coupling. The second echo at time about 10 μs is from the adhesive layer. The third echo at time of about 16 μs is the second reflection echo from the adhesive layer. Echo from the inner surface of the pipe cannot be observed at the chosen gain of the receiver but at a greater amplification it can be registered.

Fig. 3. A-Scan from the adhesively bonded area

The velocity of longitudinal ultrasonic waves in the glass reinforced material of the pipes was measured and was estimated to be about 3200 m/s. Knowing the time of each echo and the velocity of the waves, the exact distance of every reflected echo can be determined. The distance between the echo from the upper surface and the echo from the adhesive layer is about 9 mm and the distance between the adhesive layer and the inner surface of the pipe is about 4 mm. These results correspond to the data given by the manufacturer.

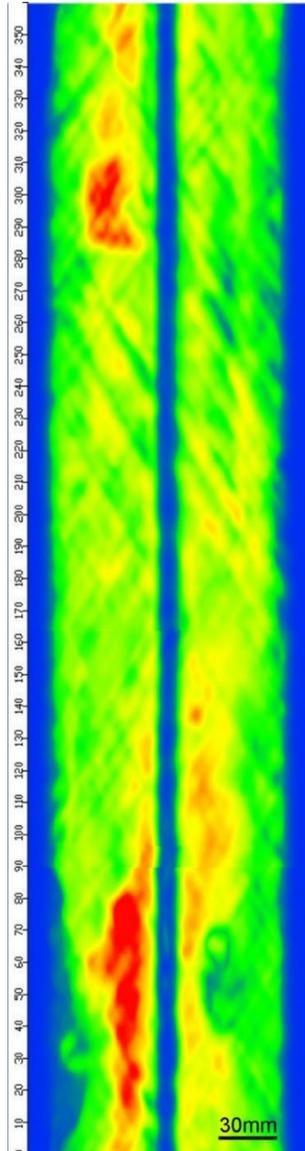
Fig. 4. Amplitude C-Scan of adhesive layer in sample 1

C-Scan was extracted for the first sample (Fig. 4). The vertical axis of the C-Scan shows the envelope of the sample with degree marks from 0° to 360°. The horizontal axis corresponds to the longitudinal axis of the coupling. The amplitude of the reflected signals is color coded, red color corresponds to high amplitude and blue color corresponds to low amplitude. The blue colored central line is due to the triangular shape of the coupling at the center of its inner surface (see fig. 1). Practically, no reflected signal was received from this area. The prevalent green color of the C-Scan corresponds to the nominal bonding between the coupling and the pipes.

The amplitude of the red colored zones in the C-Scan is 16 to 18 dB higher than the amplitude of the green colored zones. Another specific area located between 40 and 70 degrees, predominantly colored in blue, is more complicated to interpret. In this area the Time of flight (TOF) C-Scan of the adhesive layer was extracted (Fig. 5). The change of the time of flight can be clearly observed.

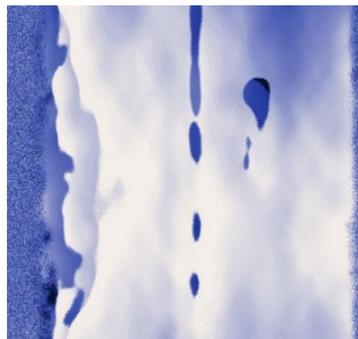
Fig. 5. Time of flight C-Scan of the same area in sample 1

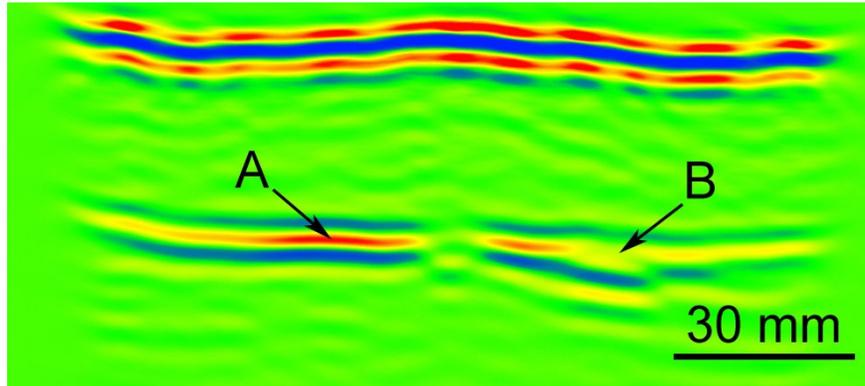
For a precise evaluation of the time of flight intervals, a B-Scan at 65 degrees from the pipe circumference was extracted (Fig. 6). This B-Scan crosses both zones having anomalies – the red colored and the blue colored on the C-scan (Fig. 4). The horizontal axis of the B-Scan represents the longitudinal axis of the coupling. The vertical axis represents the ultrasound propagation time. The series of colored stripes at the top of the image corresponds to the surface echo. The two specific areas observed on the C-Scan are marked as “A” and “B”. The area “A” is the red-colored area on the C-Scan, and “B” is the blue colored area.

Fig. 6. B-Scan at 65 degrees mark of sample 1

For area “A” the TOF of the reflection corresponds to the inner surface of the coupling. Considering the high amplitude of this reflection, it can be concluded that this is due to the lack of bonding between the coupling and the adhesive layer. For zone “B” the TOF has higher value and thus the reflector must be positioned deeper in the adhesive layer.

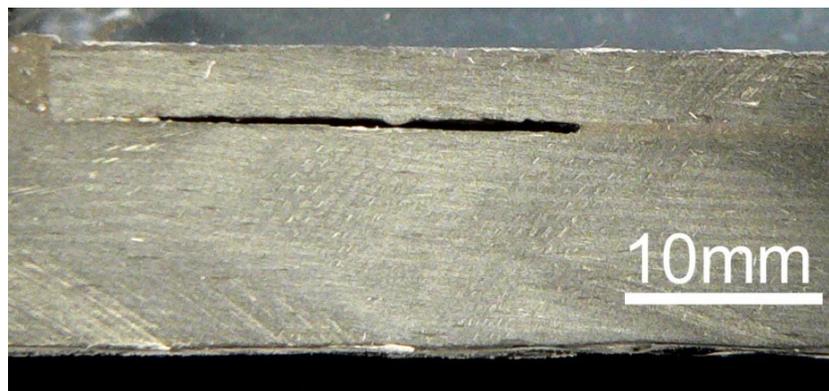
After the ultrasonic experiments, sample 1 was cut into several sections for visual validation of the results. A microscopic image of section at 80 degrees of the pipe is presented on Fig. 7. In the C-Scan this section was visible as red-colored area with a high amplitude of the reflection. A complete lack of bonding can be observed on the image. The visually measured length of the debonding is 22.3 mm which corresponds to the length of the indication in the C-Scan image (21.8 mm).

Fig. 7. Lack of bonding at 80 degrees

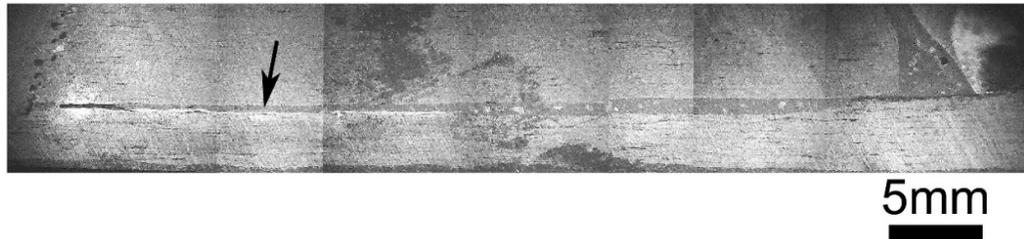
Fig. 9 shows a microscopic mosaic of the section shown as area “B” in the B-Scan. An image with larger magnification was acquired at the area marked with an arrow (Fig. 10).

Fig. 9. Foreign object between the adhesive layer and the pipe

Four distinctive layers can be observed. Zone “a” is the parent material of the coupling. Zone “b” is the adhesive layer, zone “c” is some foreign material, and zone “d” is the parent material of the pipe. The layer in zone “c” may be some thermoplastic polymer or some rubber type polymer. The visually measured length of this layer is about 20 mm and the thickness is about 0.1 mm. The length corresponds to the ultrasonically measured dimensions. Ultrasonically measured TOF exactly corresponds to the position of this foreign material between the adhesive layer and the pipe material. Later the manufacturer confirmed that the conjectures were correct.

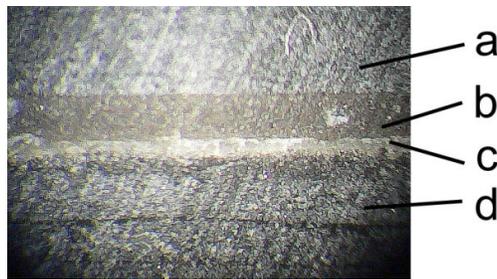
Fig. 10. Magnified picture of the foreign object
